# Comparative Manufacture and Testing of Induction-Welded and Adhesively-Bonded Carbon Fibre PEEK Stiffened Panels

*This work presents details of manufacturing and testing of a carbon fibre polyetheretherketone (CF-PEEK) induction welded hat-stiffened panel. Mechanical testing is carried out to evaluate the performance of the welded assembly and results are compared with similar testing of an adhesively bonded panel. The results show that the welded panel and the bonded panels had similar load bearing capacity (<2% difference) and stiffness (< 1% difference). Optical microscopy is used to verify the weld quality and identify manufacturing artefacts associated with induction welding. Inspection of the panel after welding shows that the induction welding process caused minor warpage, voids, and delamination in the panel. The work addresses the lack of data relating to demonstrator scale welded assemblies in the literature, demonstrates that continuous induction welding is a suitable assembly technique for aerospace and automotive components under uniaxial in-plane compressive loading, and identifies process-induced artefacts that may occur during induction welding.*

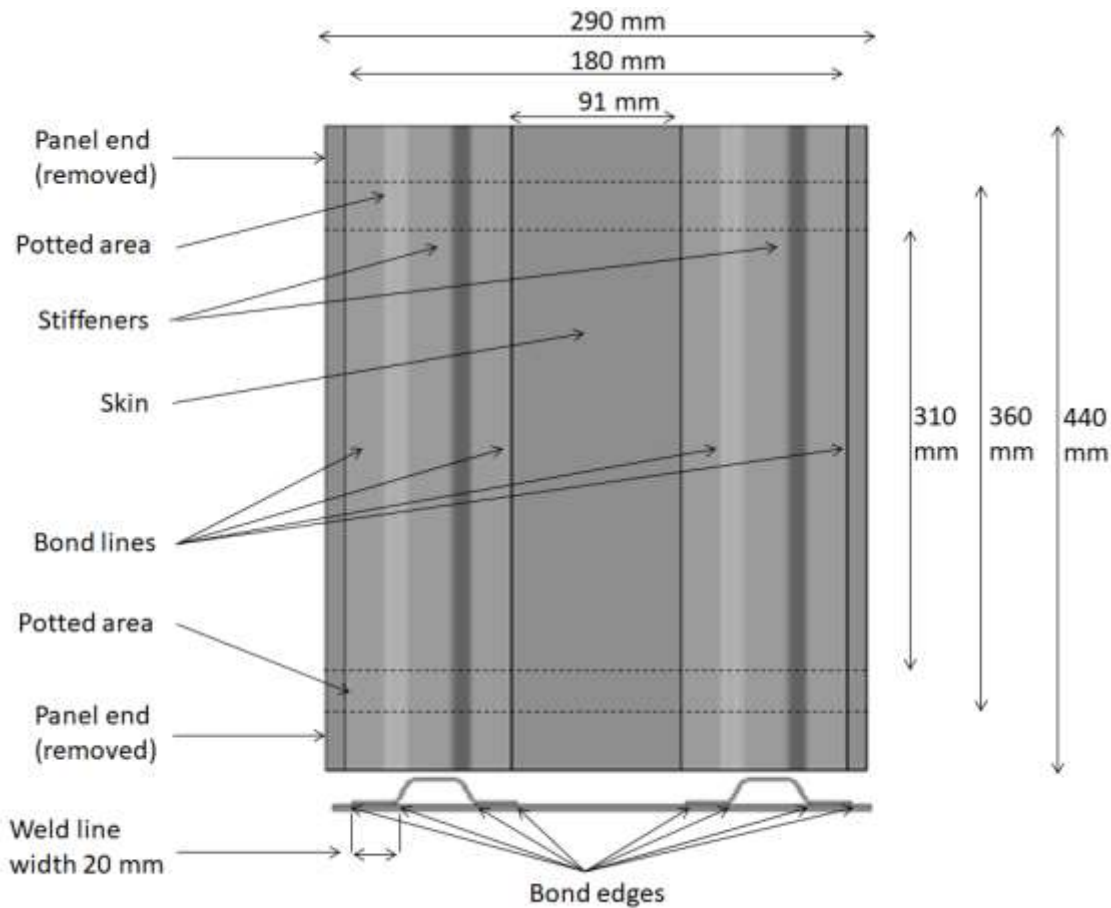
Figure 1. Geometry of stiffened panels showing features of the panels including the panel ends, potted area, test section and bond edges.

A stiffened composite panel, consisting of a flat skin reinforced with hat stiffeners is shown in Figure 1. This panel was designed as a demonstrator structure for composite joining in aerospace applications. Hat-stiffened panels are widely used in the manufacture of load bearing aerospace structures due to their specific stiffness, strength and fatigue resistance [49]. The skin of each panel was manufactured from 60% fibre volume, unidirectional carbon fibre polyetheretherketone (CF-PEEK) [50]. The layup of the skin was symmetric [90/+45/0/-45] and contained 26 plies with unequal ply percentages and a thickness of 3.6mm. The stiffeners were manufactured from 52% fibre volume 3K, 5 harness fabric reinforced CF-PEEK [51] consolidated using a heated hydraulic press. The layup of the stiffeners was [+45/-45, 0/90, 0/90]s with a thickness of 1.9mm. CF-PEEK was chosen as the material for the current study due to its toughness, environmental resistance [6], and its performance in space environments [11]. CF-PEEK is a tough thermoplastic with a glass transition temperature of circa 143°C and a melt temperature of circa 343°C. The high melt temperature of CF-PEEK also leads to high thermal stress. The process cycle for all sub-components was in accordance with the material supplier's

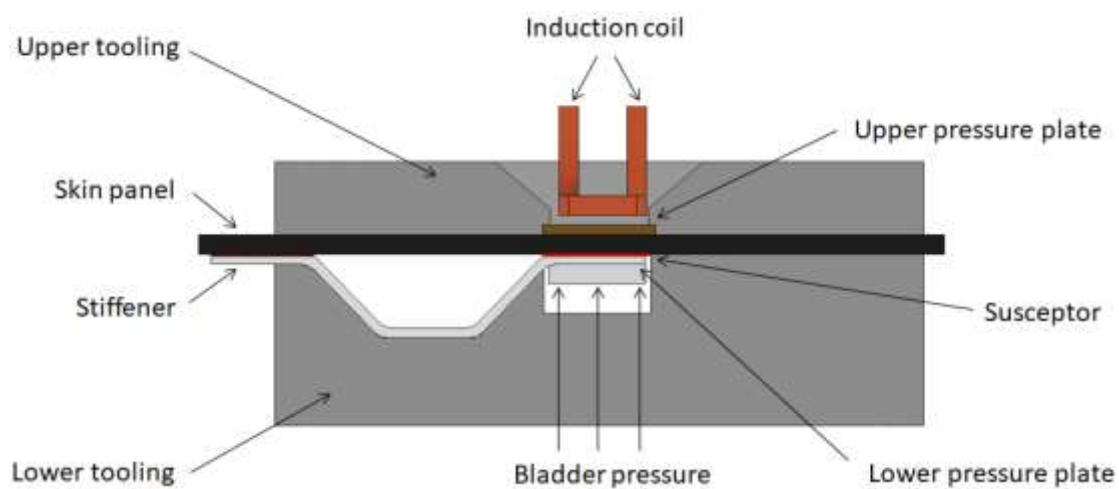
Figure 2. Section view of induction welding setup.

The stiffeners and the skin of the induction welded panel are joined together using the continuous induction welding process shown in Figure 2. Alternating electrical current is supplied to the induction coil by a generator, which is controlled and monitored using the control unit and a data acquisition system. The coil is a “double-D” geometry which is 18mm wide by 32mm long. A pneumatic pressure of 3 bar is supplied through the pressure bladder in the lower tooling and the upper tooling is stationary. A flat pressure plate is positioned between the bladder and the workpiece to ensure the pressures is evenly distributed. A transparent pressure plate is positioned directly above the workpiece; this reacts the pressure from the pressure plate and allows the

surface temperature to be monitored using an infra-red pyrometer. The upper pressure plate is cooled during welding using compressed air on the upper surface of the plate. The pressure is monitored using a pressure gauge with an accuracy of  $\pm 2.5\%$ . The current system is capable of a continuous weld up to circa 1.5m in length; however, the system could be upgraded to connect to a multi-axis robot arm in order to facilitate continuous welding of large complex geometries. A proprietary susceptor layer, highlighted in red in Figure 2, was supplied by EireComposites, (Galway, Ireland). The susceptor, consisting of a nickel coated CF mat embedded in PEEK film, 0.2mm thick and 30mm wide was inserted along the length of the weld-line. The susceptor was oversized by 5mm either side of the weld-line to eliminate susceptor miss-alignment during assembly.

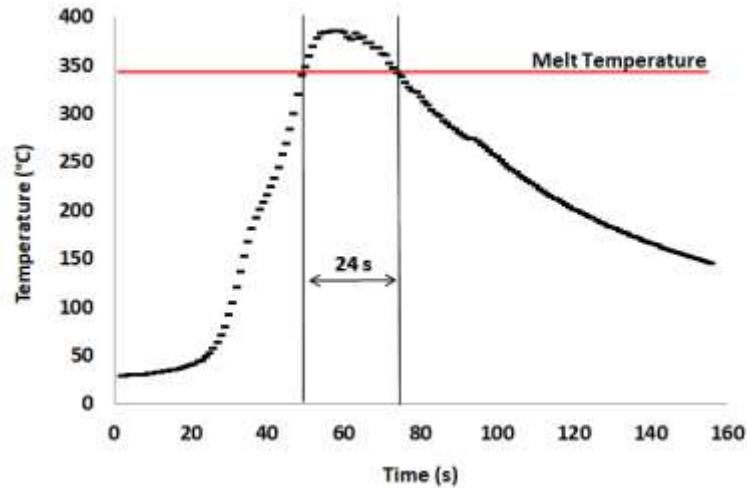
Figure 3 Weld-line temperature for trial weld, showing time above the melt temperature of CF-PEEK.

The stiffeners and susceptor layer were aligned with the skin and placed in the tooling. The induction coil was positioned 5.6 mm above the weld-line, but not in contact with either of the sub-components. An alternating current of 240-288 amps at a frequency of 620 KHz was applied to the coil and it was moved along the length of the weld-line at a rate of 1.75 mm per second. The welder current was controlled using a PID controller with the temperature on the top surface of the laminate used as the input set point. The set point of 195°C was selected so that the entire contact area of the weldline was welded. To ensure no overheating occurred, trial welds were also carried out with a type k thermocouple located at the centre of the weld-line. Figure 3 shows the temperature at the weldline as the coil moves over the weldline. The figure shows that the weldline is above the melt temperature for 24 seconds. The PID input temperature on the top surface of the skin laminate was measured during welding using an infra-red pyrometer with an accuracy of  $\pm 2^\circ\text{C}$ .

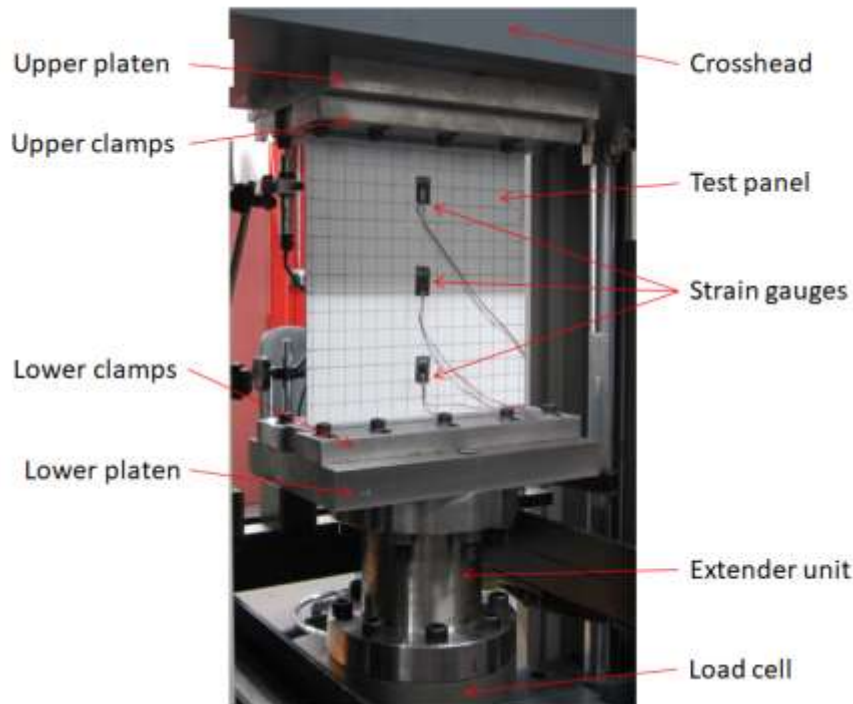
Figure 4. Test sample installed in test machine showing upper and lower platens.

The panel ends were potted in epoxy resin and machined flat to ensure that the load was transferred evenly over the entire surface area. This also allowed a cross section view of the weld-lines and bond-lines to be visually inspected. Both panels were subjected to uniaxial in-plane compression loads along the axis of the stiffeners and testing was carried out using a Zwick 400 kN screw-driven test machine, calibrated in accordance with ASTM E4-16 [55], class A. The crosshead displacement was measured using an LVDT with an accuracy of  $\pm .01\text{mm}$ . The test panels were placed between the upper and lower test platens, and clamped in place as shown in Figure 4. 12 KFG 12 $\Omega$  uniaxial strain gauges were placed along the longitudinal direction to measure the panel deformation during loading. Both samples were then loaded in compression up to 60 kN to check the alignment of the test fixtures. Metal shims were placed between the test panels and the loading fixture to correct misalignment. Once the strain gauge data for all gauges indicated compressive symmetrical loading, the panels were loaded beyond the onset of buckling to ensure that buckling behaviour was elastic. Following this the panels were loaded to failure.

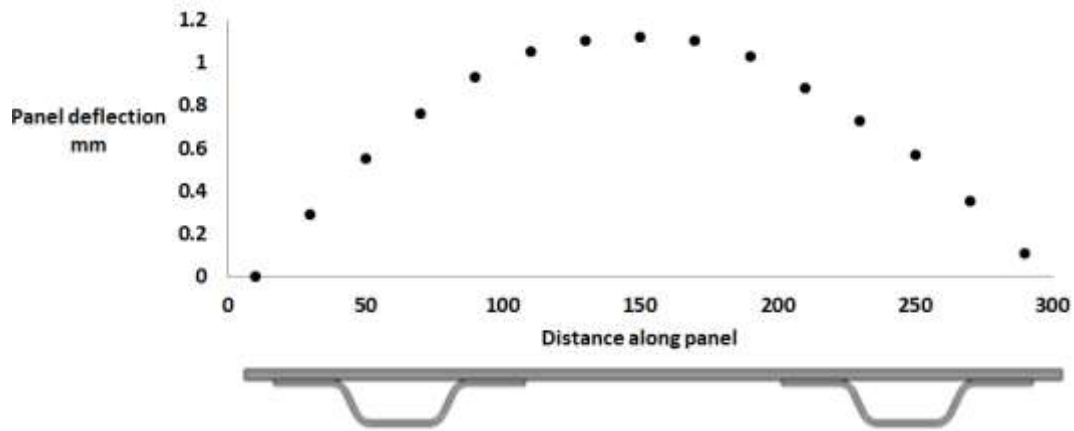
Figure 5. Graph of out of plane deflection of welded panel showing warpage of panel.

Measurement of the panel geometry after welding showed that the panel had deformed during the welding process. Warpage may occur during any thermal process, therefore it is not surprising that some warpage occurred in the current study. Fibre buckling is a means of compressive stress relief, and the presence of local buckling indicates that compressive stress has been reduced on the stiffener side of the skin. This creates an asymmetric stress distribution in the laminate which may cause warpage of the panel toward the stiffener of the panel. Other factors that may affect buckling are the clamping conditions, thermal expansion mismatch between the stiffener and the skin, or a change in crystallinity in the heat affected zone. During manufacture, the ends of the panel were subject to excessive heating which caused major defects in this area. Although this area was

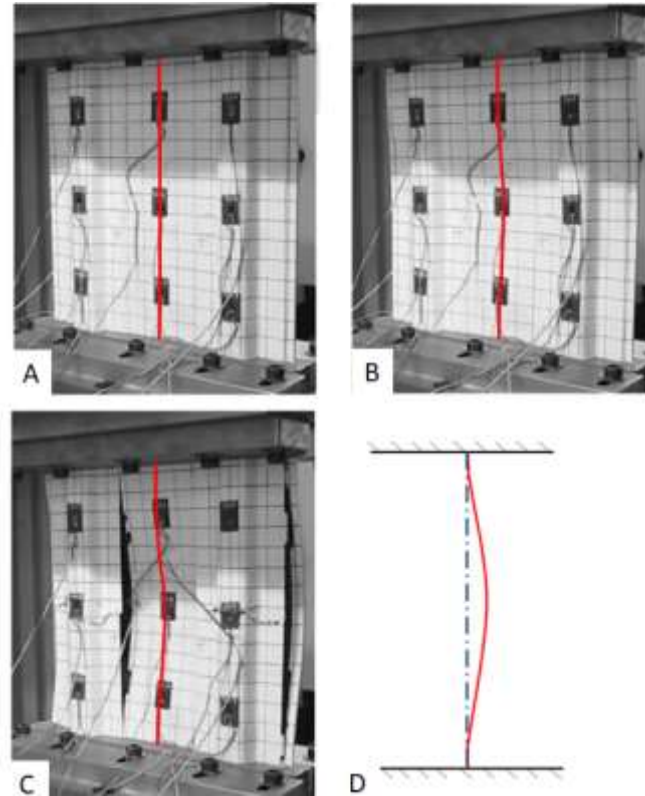
Figure 6. Images of adhesively-bonded panel with panel deformation highlighted by a red spline (A) Loaded prior to buckling (B) Buckled panel (C) Panel post failure (D) Image of buckling behaviour of a plate fixed at both ends with un-buckled deformation highlighted by the broken blue line and the buckled deformation highlighted by a solid red spline.

The buckling and failure behaviour of the panels during testing are illustrated in Figure 6. Figure 6A shows the adhesively-bonded panel under load, prior to buckling. Figure 6B shows the panel in a buckled state and Figure 6C shows the panel post failure (a grid pattern has been painted on the surface to highlight panel deformation). Figure 6C shows that the stiffeners have failed across the mid-height of the panel and have detached from the skin of the panel. Comparing the panel buckling in Figure 6B to theoretical buckling in Figure 6D indicates that the panel behaviour is similar to that of a theoretical flat plate fully restrained against rotation at both ends.

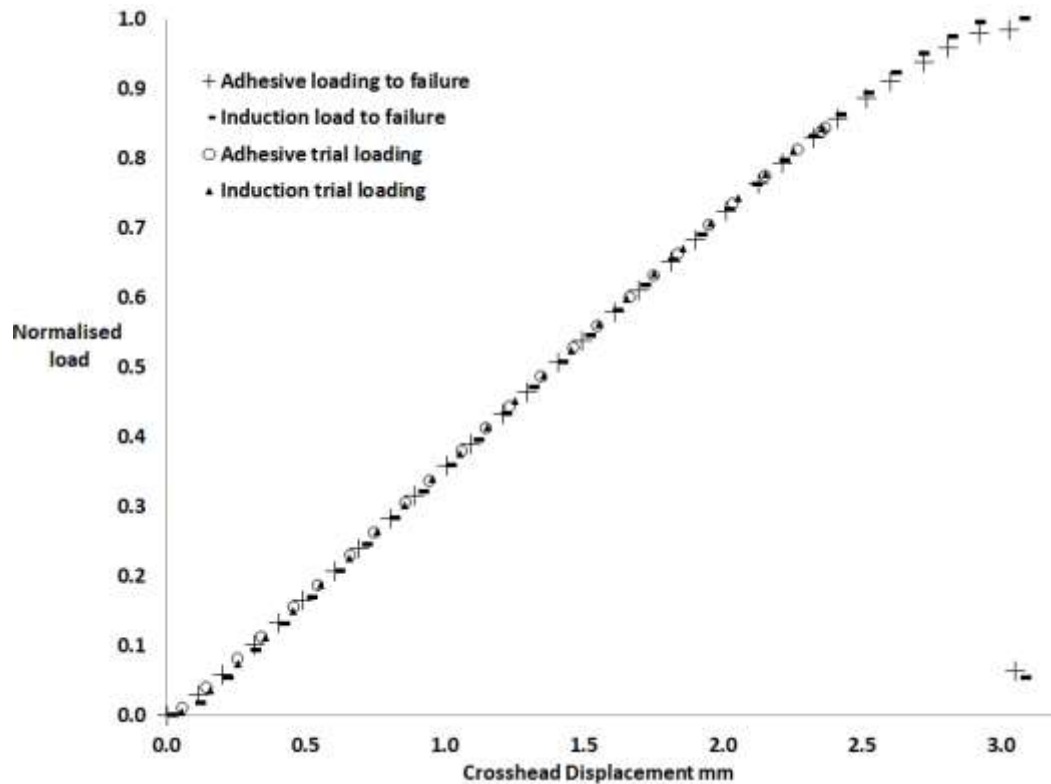
Figure 7. Load displacement graph for the adhesively-bonded and induction welded panels showing trial loading and loading to failure of each panel. For loading to failure of each panel the nonlinearity due to buckling and post failure load-carrying capacity can be seen.

Figure 7 shows the load-deflection curves for the induction welded and adhesively-bonded panels. The induction welded panel failed at a load of 370 kN, and the adhesively bonded panel failed at 361 kN. The load for both panels has been normalised against the failure load of the induction welded panel. Trial loading to circa 80% of the failure load, and loading to failure is shown for each panel. The load deflection graphs for both panels show an initial non-linearity due to bedding in of the test machine and fixtures. After this initial non-linearity, both panels show a linear load-deflection response up to circa 70% of the failure load. Above 70% of the failure load, the responses of the panels become non-linear and diverge slightly from each other. This non-linearity indicates that there is a loss of stiffness representing the onset of buckling. Comparison between the trial loading and the loading to failure of both panels shows that the load response of the panels was repeatable and there were no signs of damage in the panels. This indicates that the buckling was elastic. Following buckling, both panels failed at similar loads and crosshead displacements, with the adhesively bonded panel failing at 98% of the failure load of the welded specimen.

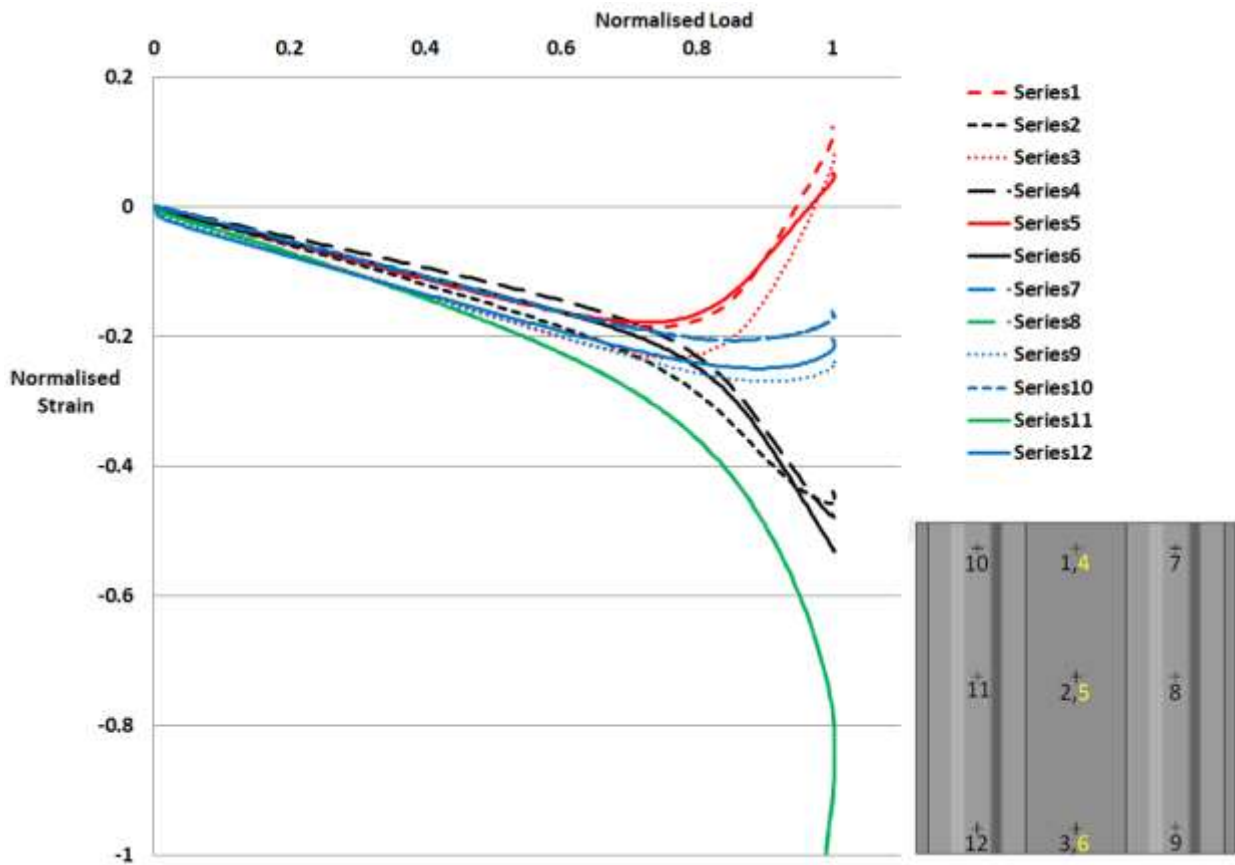
Figure 8. Strain gauge locations and response to loading for the induction welded panel. The gauge locations are marked by a cross, black gauge numbers are located on the stiffener face of the panel and yellow numbers are located on the flat face of the panel. All gauges are orientated in the loading direction. Note that the data for gauges 8 and 11 and gauges 7 and 10 overlap one another and cannot be distinguished from one another in the above graph.

Figure 8 and Figure 9 show the strain gauge response for loading to failure of both panels. The strain gauge data has been normalised against the maximum strain experienced by the panels. The grouping of all gauges at the start of loading and the response of gauges on each stiffener verifies that the panel was well aligned in the test machine. The figures show that the strain responses for equivalent gauges on both panels are similar. Gauges that behave in a similar manner have been colour coded in order for ease of comparison. The strain at any point in the structure is the sum of the strain due to the compression loading and the strain due to bending caused by the onset of buckling. Initially the compressive strain in all gauges increases linearly with increased load. At approximately 70% of the failure load both panels start to buckle. At this point the rate of change of strain increases with increase in load for strain gauges 2, 4, 6, 8, and 11, while the rate of change of strain reverses for gauges 1, 3, 5, 7, 9, 10, and 12. As the load increases, the strain becomes positive for gauges 1, 3, and 5, indicating that the surface ply of this area of the panel goes into tension. This is due to the superposition of the bending strain due to buckling, and the compressive strain in each gauge. The strain gauge data indicates that the panels with fixed ends behaved as indicated in Figure 5D and that buckling occurred gradually as the load increased.

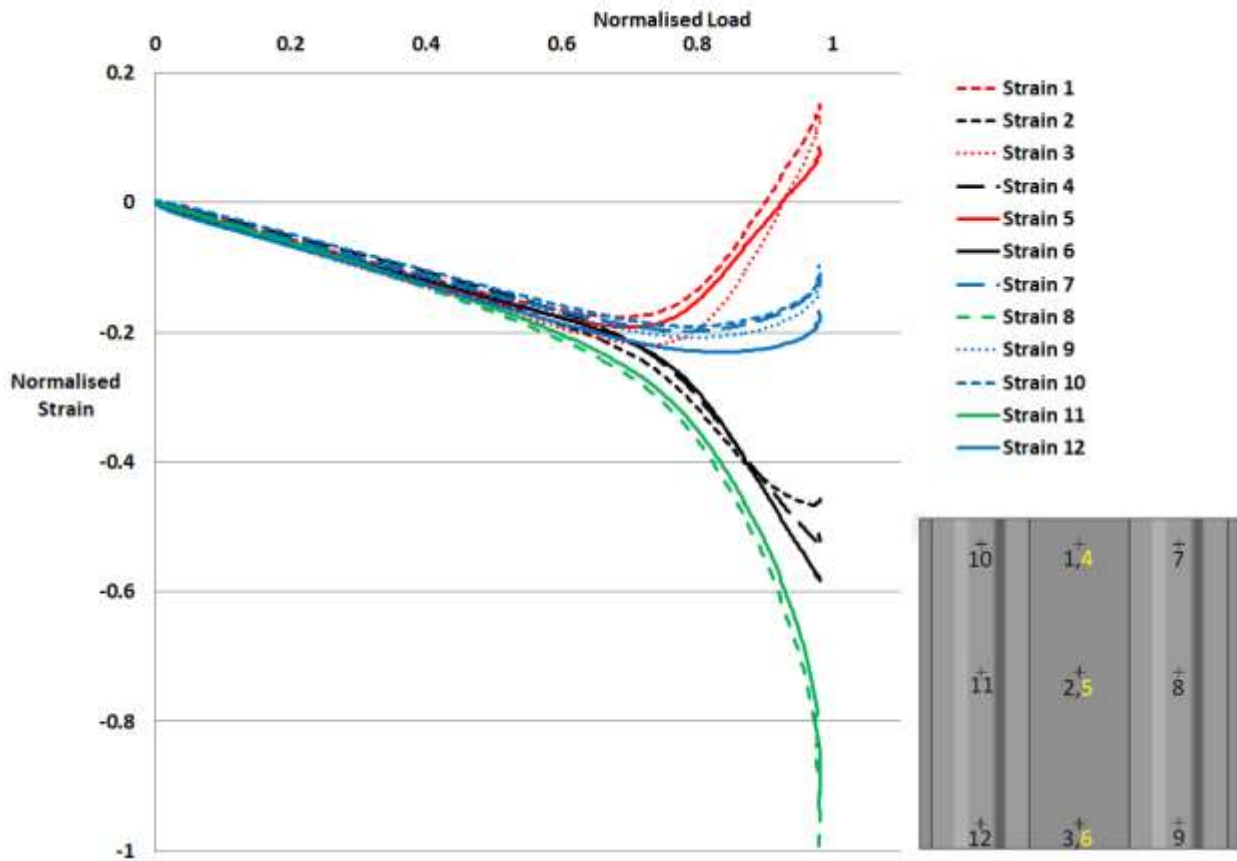
Figure 9. Strain gauge locations and response to loading for adhesively-bonded panel. The gauge locations are marked by a cross, black gauge numbers are located on the stiffener face of the panel and yellow numbers are located on the flat face of the panel. All gauges are orientated in the loading direction.

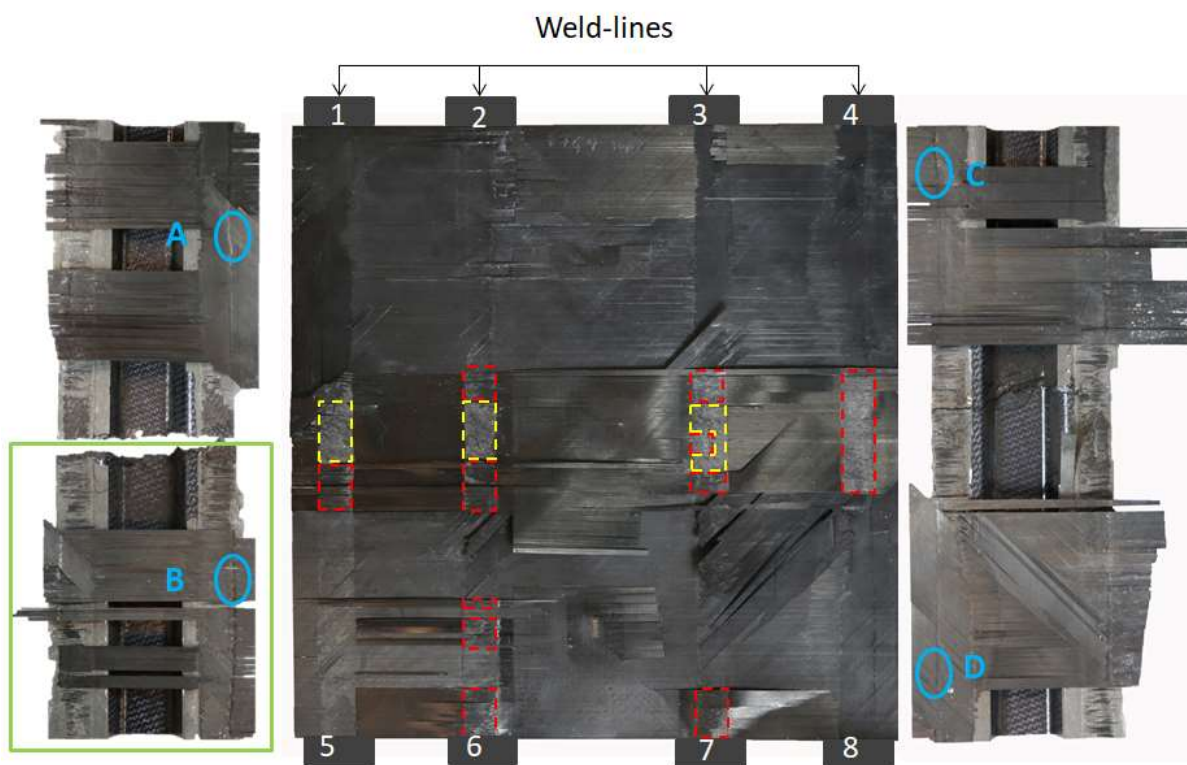
Figure 10. Welded panel dismantled following testing, showing the skin of the panel in the centre and the stiffeners on the right and left. The locations marked 1 to 8 indicate the areas from which micro-sections were extracted. The areas highlighted by yellow dashed lines are areas that have failed via adhesive failure between the stiffener and the susceptor. The areas highlighted in red dashed lines have failed via adhesive failure between the susceptor and the panel. The areas highlighted in green and blue solid lines are shown in more detail in the following figures.

Post-test inspection of the welded panel showed that the stiffener had detached along the length of the panel. Figure 10 shows the welded panel disassembled following failure. The potted ends of the panel were removed from the panel and micro-sections were extracted at locations 1 to 8 in Figure 10. For the purpose of this discussion adhesive failure is failure at a weld surface between the susceptor and the composite surface,

cohesive failure is failure in the susceptor, and substrate failure is failure in the substrate of the composite. The stiffeners of the panel have fractured across their mid height at strain gauge locations 8 and 11. Areas that have failed via adhesive failure between the stiffener and the susceptor are highlighted in yellow. Areas that have failed via adhesive failure between the susceptor and the panel are highlighted in red. For the remainder of the weld-line, the substrate of the panel failed and the majority of the weld-lines remained intact. In general, the joint failed adhesively between the CF-PEEK and the susceptor material at the mid-height of the panel. Away from the mid-height of the panel, the failure transitions to substrate failure in the skin panel. Much of the top ply, and in some areas the second ply, has remained welded to the stiffeners. In areas where the first ply has been removed, the welded area of the composite is highlighted by a slight change in texture and appearance as seen in Figure 10. The areas highlighted in green and blue contain several defects which are examined in more detail in Figure 11 and Figure 12.

Figures 10 and 11 shows that all the interply fracture surfaces have a matt appearance, apart from some of the edges of the weld-lines where the material has a glossy surface. Figure 12, A, B, C, and D show microscopic images of the glossy areas highlighted by the green circles in Figure 10. Figure 12, E shows a typical fracture surface away from the weld-lines between the first and second ply. Figure 12, A, B, C, and D all show a distinctly different fracture surface to Figure 12 E. The PEEK matrix, located on the fracture surface, has round edges at several locations showing that it was formed by thermal processing as opposed to fracturing of the part. This shows that these locations represent voids/delamination in the part which were created during thermal processing. The glossy area at the edge of the weld-line is the only area that showed these patterns.

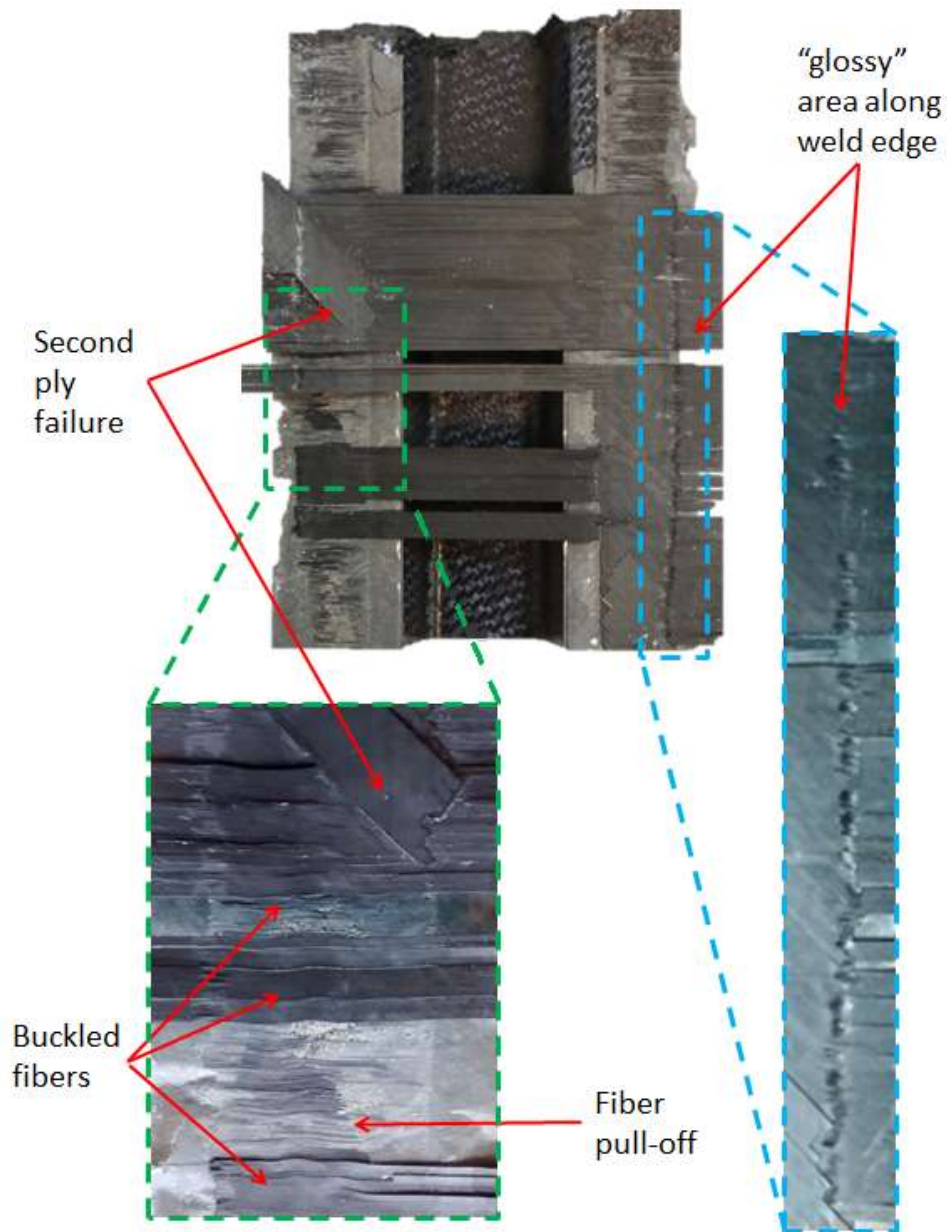
Figure 11. Close up of welded-stiffener fracture surface highlighted in green in Figure 10 showing second ply failure, buckled fibres and glossy weld edge appearance.

Figure 11 shows a close up of the bottom of the left hand stiffener from Figure 10, which highlights the second ply failure, buckled fibres, on the top ply of the laminate, and the glossy appearance at the edge of the

weld-line. The area in Figure 11 where the panel has failed via adhesive failure between the susceptor material and the skin shows that fibres have been pulled off the surface of the top ply along the centre of the weld-line. This indicates that a strong bond was formed between the weld-line and the laminate skin. Fibre pull-off was also evident in areas where the weld failed via adhesive failure between the stiffener and the susceptor again indicating a strong bond. The majority of the failure occurred either by adhesive failure between the skin and the susceptor, or failure of the substrate of the panel.

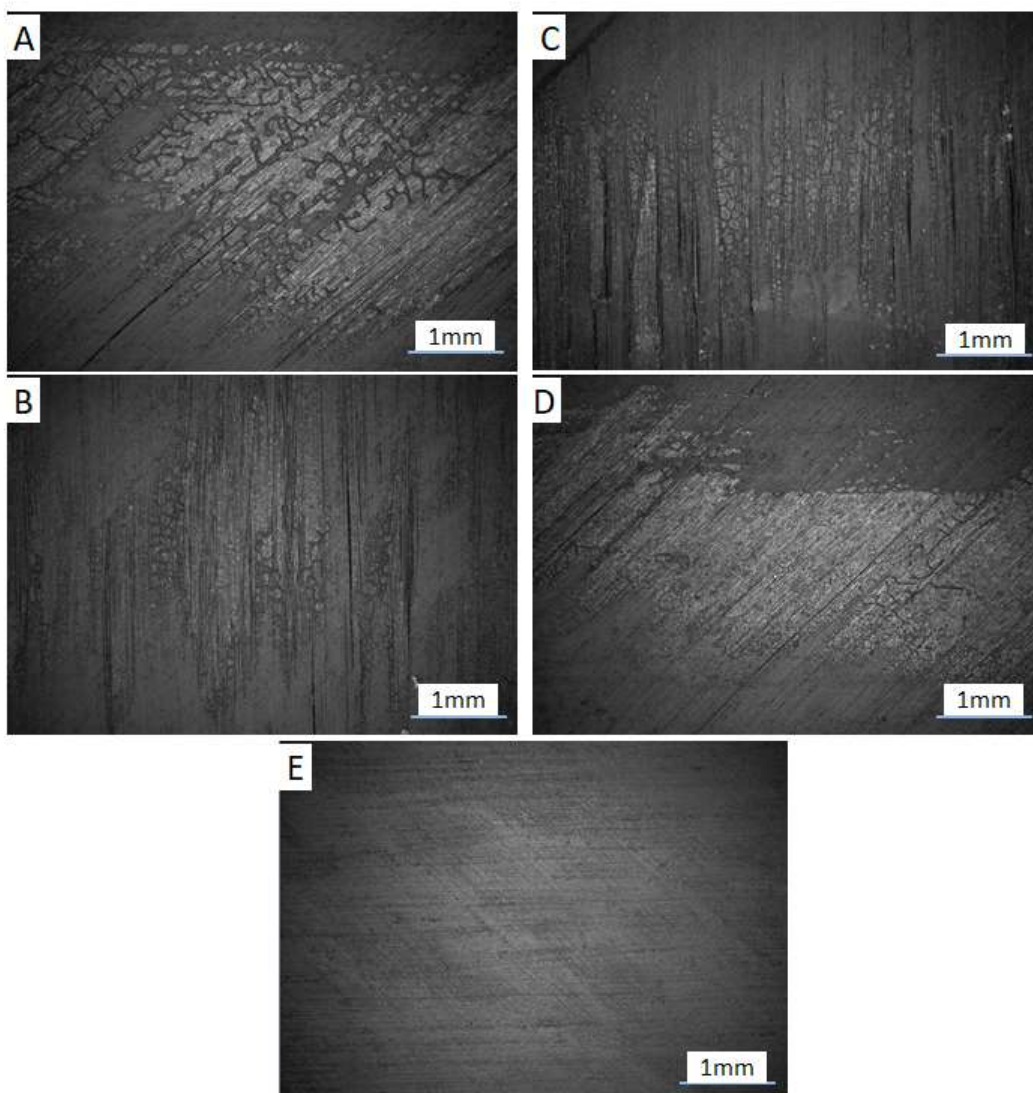
Figure 12, A,B,C and D represent the fracture surface at the glossy area at locations A,B,C and D in figure 10. Each image shows formations of melted peek that indicate voids/delamination were formed during thermal processing. Figure 12, E shows a typical fracture surface away from the welding. Fracture surfaces A and D are between the second and third ply. Fracture surfaces B and C are between the first and second ply.

surface were examined under a microscope and revealed melted PEEK formations between the first, second and third plies. Optical microscopy of 9 intact micro-sections removed from the panel revealed the presence of voids and delaminations at the weld edge in 7 out of the 9 samples. The glossy area on the panel and the delaminations identified in the panel were found to be in the same location as the voids and delamination. This indicates that the glossy areas on the fracture surface of the plies are delaminations between the plies. The locations of these defects at the edges of the weld-line indicate that the defects were caused by the welding process. Visual examination of the entire fracture surface has shown that the glossy regions were present between the first and second ply, as well as between the second and third ply, and were up to 3mm wide in places.

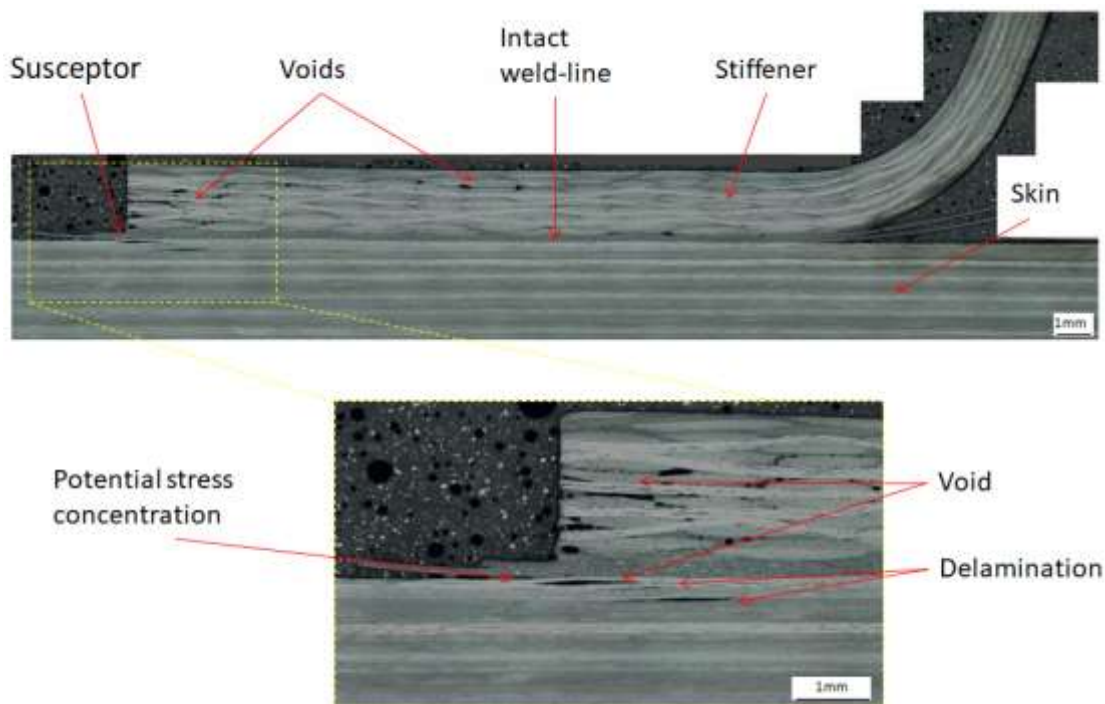
Figure 13. Micro-section of stiffener and skin, taken from the top of location 1 in Figure 10, showing intact weld-line and process induced voids and delamination.

Eight welded sections were extracted from ends of the failed panel and two sides of each section were polished in order to inspect the microstructure of the weld and the surrounding composite. The sections were removed after testing but prior to panel disassembly to preserve any intact welds at the panel ends. Inspection of the weld-lines showed that the weld-lines were well consolidated with a low void content. Figure 13 shows a representative micro-section of a weld-line taken from the top of location 1 in Figure 10. The figure shows an intact, well consolidated, weld-line between the stiffener and the skin with very few voids. The figure also shows voids in the stiffener, delaminations and one void in the skin, and potential stress concentrations at the weld edges. The location of the delaminations in the skin along the edge of the weld-line between the first, second and third ply coincides with the glossy areas highlighted in Figure 11 and Figure 12. Of the 16 micro-sections examined, 7 contained voids at the edge of the weld-line in the top plies of the skin, similar to those shown in Figure 13, while two did not contain voids at this location and 7 were inconclusive as the welded joint had failed. This indicates that the glossy areas of the panel represent delaminations in the top plies.

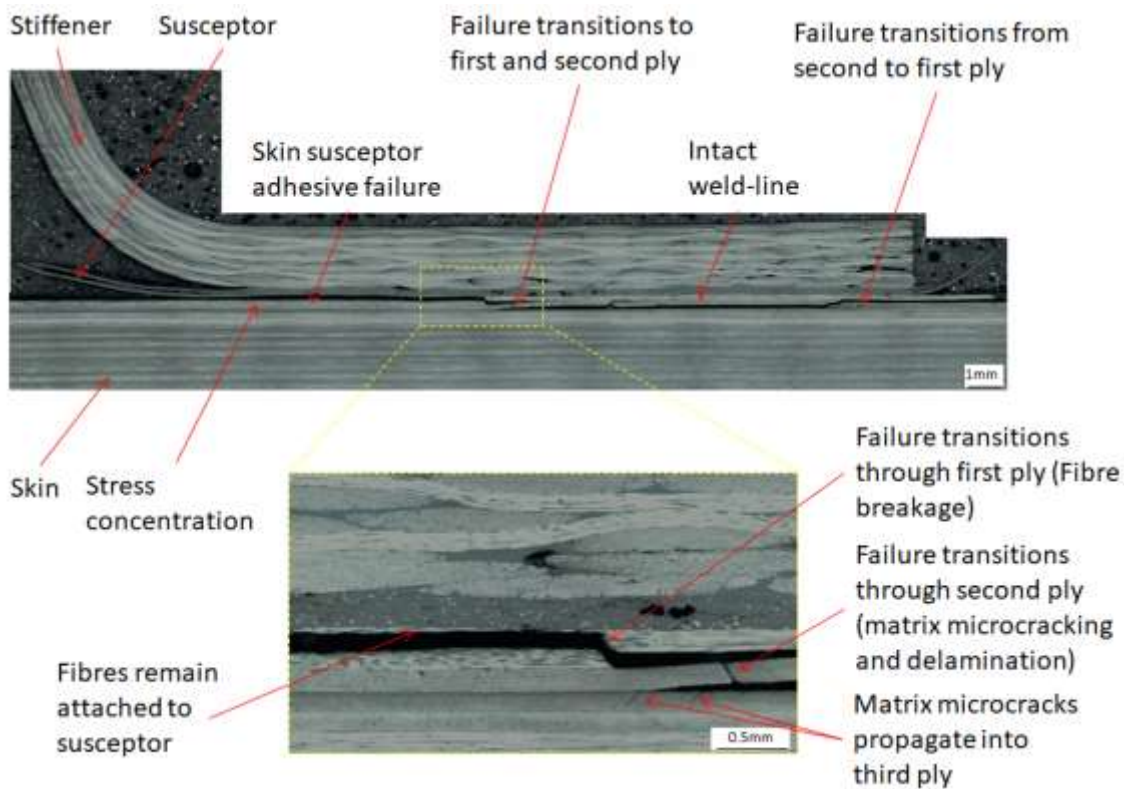
Figure 14. Micro-section of failed weld-line, taken from the bottom of location 1 in Figure 10, showing adhesive failure between the susceptor and the skin and failure in the first and second ply of the skin.

Figure 14 shows a micro-section of a failed weld-line taken from the bottom of location 1 of Figure 10. On the left hand side of the weld-line, the weld has failed adhesively between the susceptor and the skin of the panel. Near the centre of the weld-line, the failure transitions through the second ply and causes a delamination along the centre of the weld-line. The image shows that the failure has transitioned through the first ply via fibre

breakage and through the second ply via matrix micro-cracking. Micro-cracking can also be seen in the third ply of the laminate. On the right hand side of the weld-line, the failure transitions back through the first ply causing a delamination between the first and second ply. Figure 14 also shows potential stress concentrations at both edges of the weld, potential stress concentrations were found on all welds examined. There was no evidence of process induced defects seen in the skin of the laminate at the location examined; however, this may be because the delamination passed through, or initiated at the defect and is no longer visible. Although there were local areas of high porosity at the free edge of the stiffener, a void analysis of the entire welded area of the stiffener foot from Figure 13 and Figure 14 showed that the void content of the stiffener was below 1.5%. The void analysis was carried by applying a threshold to a micro-section image of the stiffener and calculating the number of pixels below this threshold as a percentage of the total pixels using ImageJ [56].

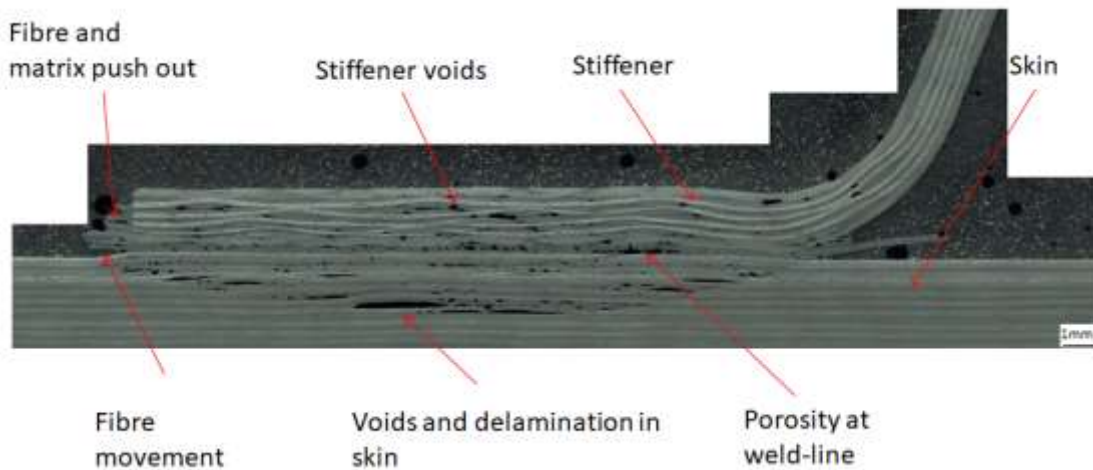
Figure 15. Micro-section of an offcut taken from the end of the panel showing an area where the weld-line was overheated. Process induced defects can be seen throughout the heat affected zone of the laminate.

Figure 15 shows a micro-section taken from a weld run in at the end of the panel, where overheating was observed following welding. This area is part of the area that was removed prior to testing. The figure shows several process induced defects in the heat affected zone in both the stiffener and the skin of the panel with defects in the skin located as far as 15 plies into the panel. At the edge of the stiffener, fibres and matrix have been pushed out and have deformed locally. Voids and delaminations can be seen in the skin of the panel, while

voids can also be seen in the stiffener and in the weld-line itself. The voids and delaminations in the skin form a “deconsolidation front” similar to that shown by Ageorges and Ye [57]. This offcut illustrates the potential problems that occur when an area is overheated during welding and highlights the need for process control during welding.

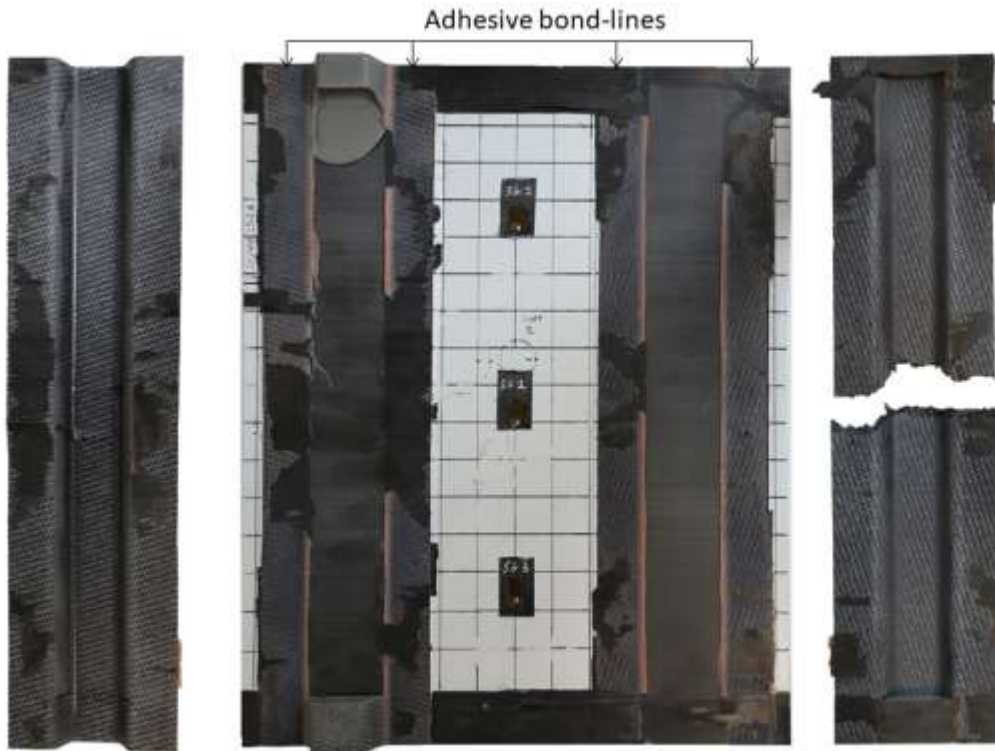
Figure 16. Adhesively-bonded panel dismantled following testing showing the skin of the panel in the centre and the fracture surface of the stiffeners on the right and left.

Figure 16 shows the adhesively bonded panel disassembled following failure. Post-test inspection of the adhesively bonded panel showed that the stiffener had detached along the full length of the panel. The stiffeners of the panel have fractured across their mid height at strain gauge locations 8 and 11. Areas where the pink adhesive can be seen on the surface of the panel failed due to adhesive failure between the stiffener and the adhesive. The remainder of the bond failed due to adhesive failure between the skin and the adhesive. Close examination of the bond area showed that the adhesive had pulled out individual surface fibres and caused local delaminations in the bond area. This indicates that a strong bond had been formed between the adhesive and the sub-components along the full length of the stiffener.

Post-test inspection of the adhesively bonded panel showed that the joint failed via (i) adhesive failure between the adhesive and the stiffeners and (ii) adhesive failure between the adhesive and the panel. The bonded joint also caused the surface ply to delaminate in the area under the bond-line, indicating that a strong bond was formed. No process induced defects were found.
